CAFO FACILITY INSPECTION REPORT

<p><u>8365978001</u> WDID NUMBER</p> <p><u>CAG018001</u> NPDES NUMBER</p> <p><u>R8-2007-0001</u> RWQCB ORDER NO.</p> <p>SCHEDULED INSPECTION DATE</p> <p><u>03/06/2013</u> ACTUAL INSPECTION DATE</p> <p><u>Unknown</u> RECEIVING WATER</p>	<p><u>James Jongsma</u> OWNER NAME</p> <p><u>Ex. 6 Personal Privacy (PP)</u> OWNER ADDRESS</p> <p><u>Pixley, CA 93256</u> OWNER CITY AND STATE</p> <p><u>James Jongsma</u> OWNER CONTACT</p> <p><u>Ex. 6 Personal Privacy (PP)</u> OWNER PHONE NO.</p> <p><u>Ex. 6 Personal Privacy (PP)</u> FACILITY LATITUDE</p>	<p><u>James & John Jongsma Dairy</u> FACILITY NAME</p> <p><u>Ex. 6 Personal Privacy (PP)</u> FACILITY ADDRESS</p> <p><u>Ontario, CA 91762</u> FACILITY CITY AND STATE</p> <p><u>Brian Jongsma</u> FACILITY CONTACT</p> <p><u>Ex. 6 Personal Privacy (PP)</u> FACILITY PHONE NO.</p> <p><u>Ex. 6 Personal Privacy (PP)</u> FACILITY LONGITUDE</p>
---	--	--

On March 6, 2013, a Concentrated Animal Feeding Operation (CAFO) inspection was conducted for Santa Ana Water Board Order No. R8-2007-0001 - 'General Waste Discharge Requirements for Concentrated Animal Feeding Operations (Dairies and Related Facilities) within the Santa Ana

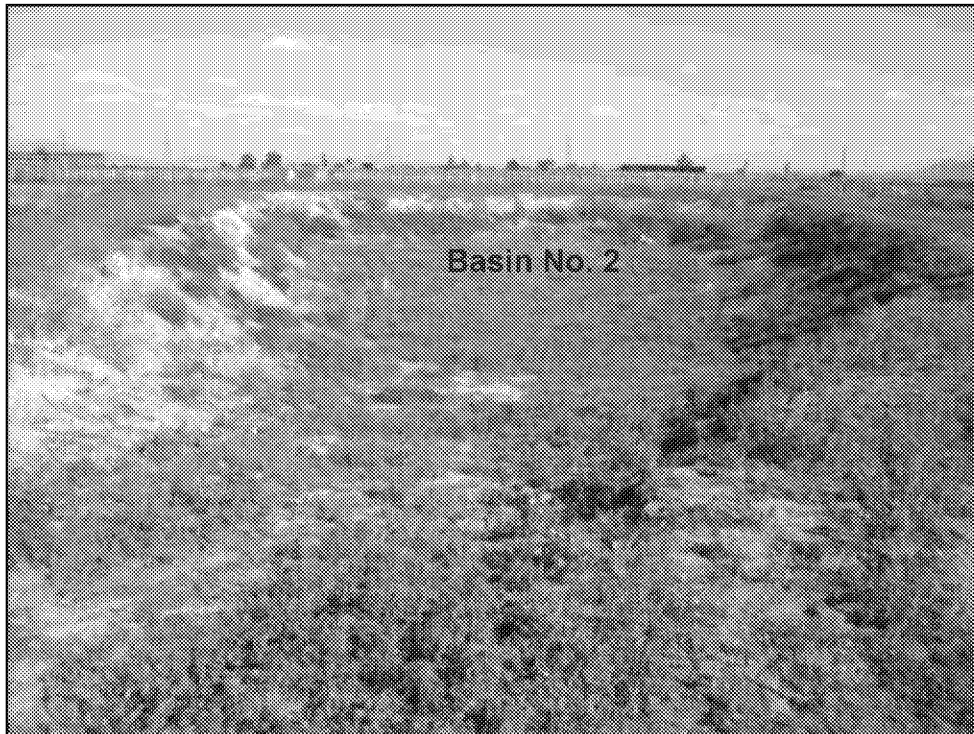
- Depth markers were not installed in basin Nos. 1 and 2 (refer to Photos 2 and 3)
- The depth marker in lagoon No. 1 did not contain depth measurement markings (refer to Photos 4 through 7)
- Daily inspections of all ponds, berms, and wastewater distribution and application equipment was not conducted or documented
- The Engineered Waste Management Plan (EWMP) was not retained onsite or available for review at the time of the inspection
- The EWMP was not fully implemented onsite at the Facility
- Vegetative growth was observed in lagoon No. 1 (refer to Photos 4 through 7)
- Accumulated solids were observed in disposal field No. 2 (refer to Photos 10, 11, and 12)

1. Depth markers were not installed in basin Nos. 1 and 2 as required by Permit Attachment B - Monitoring and Reporting Program, Section I.B.1 (refer to Photos 2 and 3).

1. The inspectors observed, during the inspection, that depth markers had not been installed in basin Nos. 1 and 2 located in the northeast, and central-east portion of the Facility to indicate the minimum capacity necessary to contain the runoff and direct precipitation of the 25-year, 24-hour rainfall event, as required by Permit Attachment B - Monitoring and Reporting Program, Section I.B.1 (refer to Photos 2 and 3).
2. The inspectors observed, during the inspection, that the depth marker installed in lagoon No. 1 did not have measurement markings on the depth marker pole to clearly identify lagoon depth and freeboard (refer to Photos 4 through 7). Mr. Jongsma stated that the lagoon No. 1 depth marker should have depth measurement markings. In addition, he stated that he would evaluate and repair the depth marker to clearly identify depth measurement markings following the inspection.

Photograph 2. View facing east of basin No. 2. Note the basin did not contain a depth marker.

1. Verify whether or not depth markers have been installed in basin Nos. 1 through 3
2. Verify whether or not the EWMP is retained onsite
3. Verify whether or not daily inspections are conducted at the Facility during the wet season, per the approved EWMP
4. Verify whether or not the lagoons and basins are free of excessive vegetation growth
5. Verify whether or not process wastewater solids are removed from the fields annually

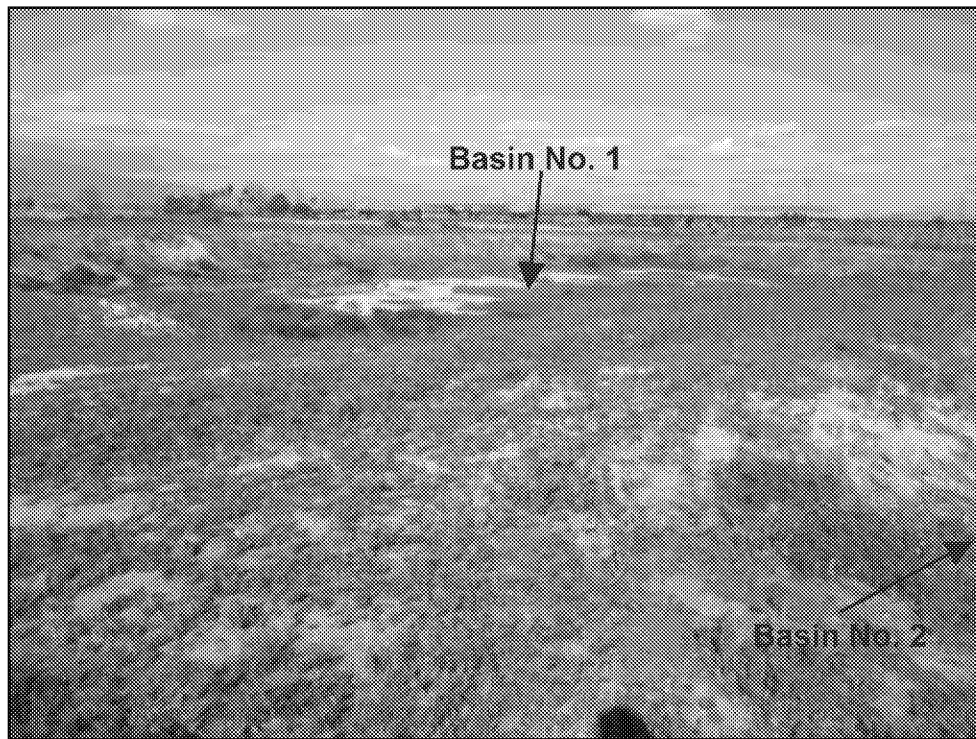
Photograph 3. View facing northeast of basin No. 1. Note the basin did not contain a depth marker.

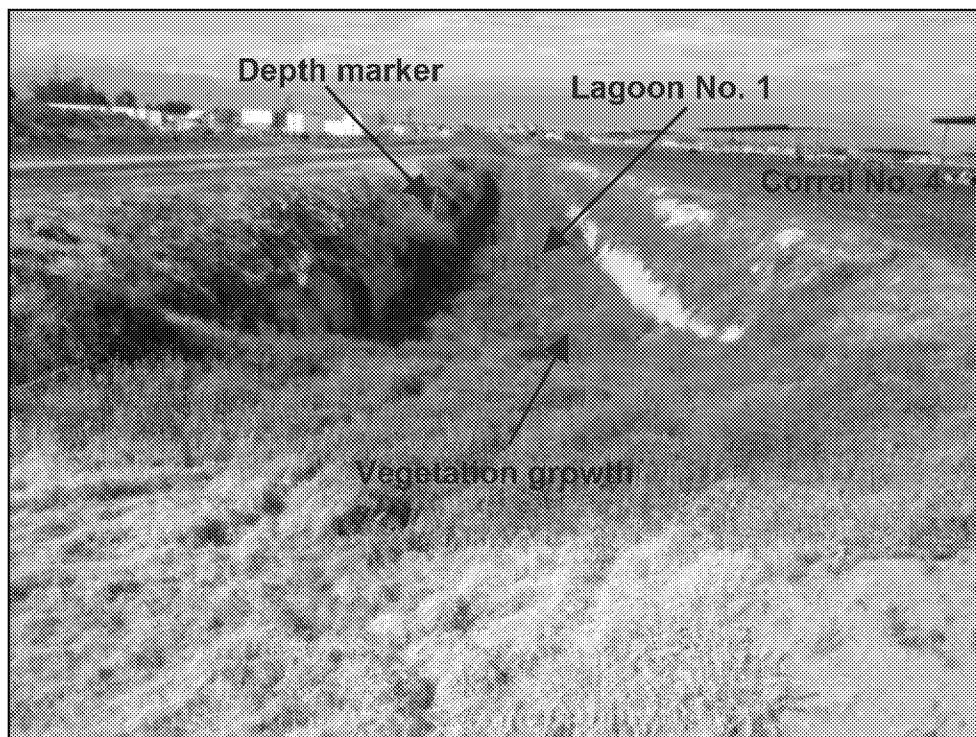
4. Vegetation growth was observed in lagoon No. 1 in the central-west portion of the Facility (refer to Photos 4 through 7). The Discharger must design and maintain all containment structures per the EWMP as required by Provision VII.C.3.a of the Permit.

1. The inspectors observed, during the inspection, that vegetation growth potentially affecting the containment structure capacity was present in lagoon No. 1 (refer to Photos 4 through 7). The 'Operation and Maintenance' section of the EWMP states that "weed abatement measures such as pesticides and clearing and grubbing should be used to control weeds in fields, lagoons, wastewater transport channels, and wastewater access paths." As a result, the overall capacity of lagoon No. 1 at the Facility may be diminished. Provision VII.C.3.a of the Permit states that "the discharger shall design, construct, and maintain containment structures to retain all wastewater within the facility, including all process wastewater and all precipitation on, and drainage through, manured areas resulting from rainfall up to and including a 25-year, 24-hour rainfall event." The Discharger must design and maintain all containment structures per the EWMP as required by Provision VII.C.3.a.

Photograph 4. View facing north of lagoon No. 1. Note the vegetation growth in the lagoon.

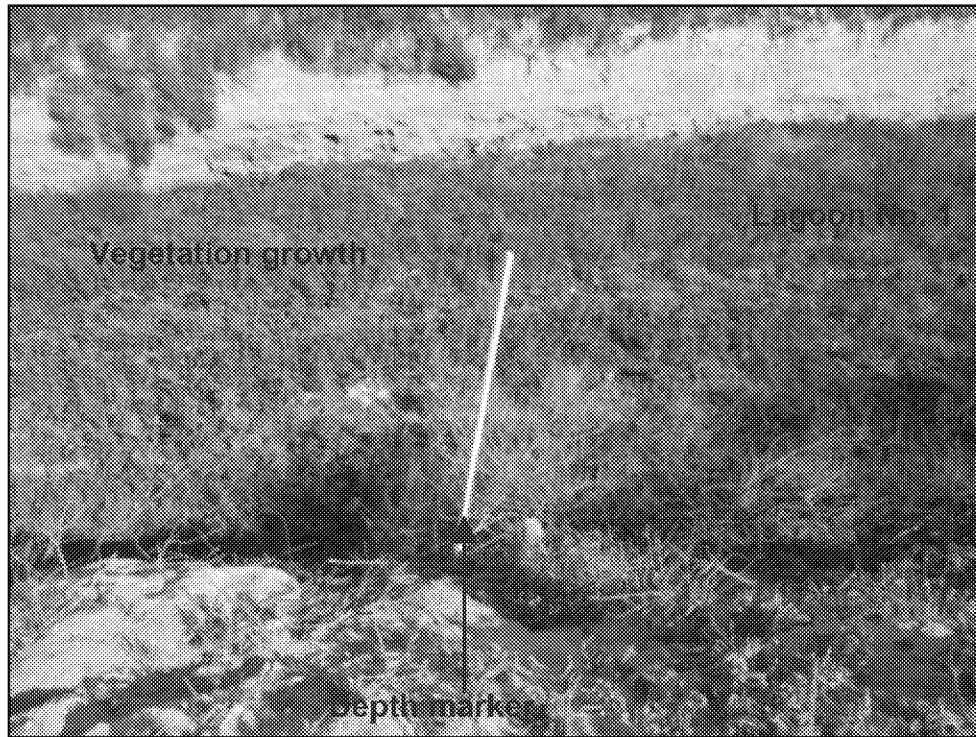
Photograph 5. View facing east of the depth marker installed in lagoon No. 1. Note the depth marker did not have depth measurement markings. Also note the vegetative growth in the lagoon.

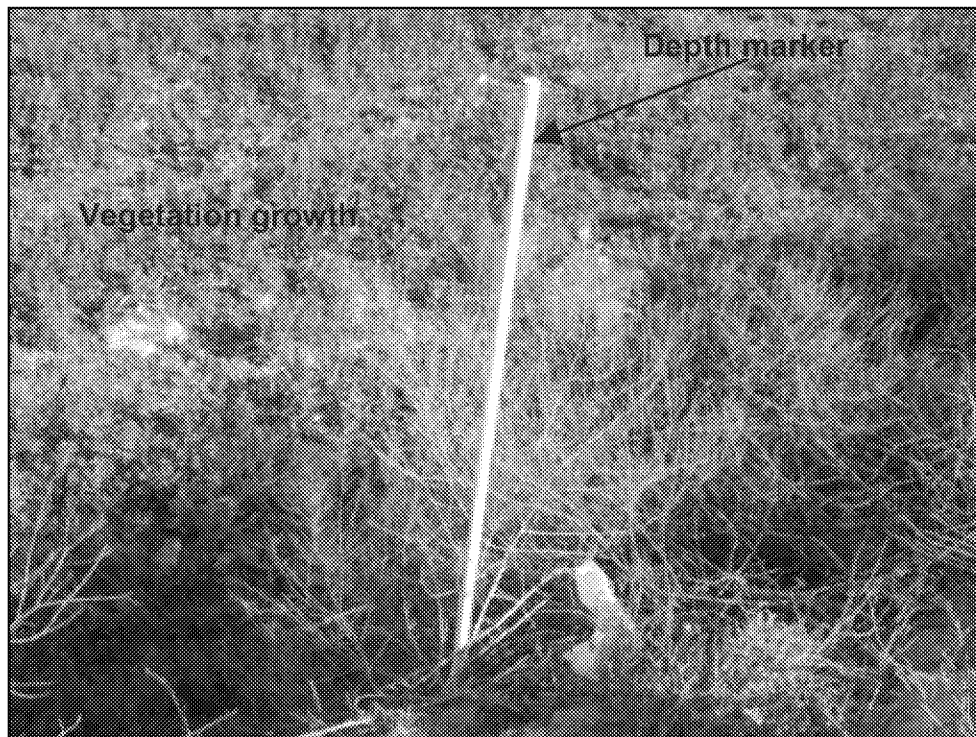
Photograph 6. Close-up view of the vegetative growth and depth marker installed in lagoon No. 1. Note the depth marker did not have depth measurement markings.

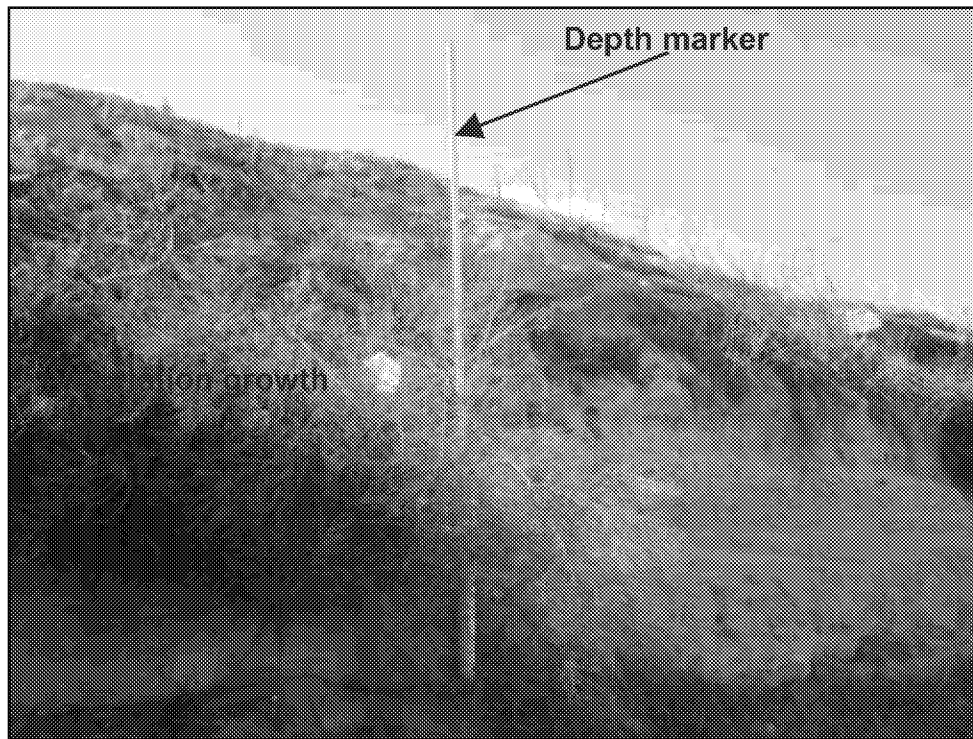
Photograph 7. Close-up view facing northwest of the depth marker installed in lagoon No. 1. Note the depth marker did not have depth measurement markings. Also note the vegetative growth on the embankment.

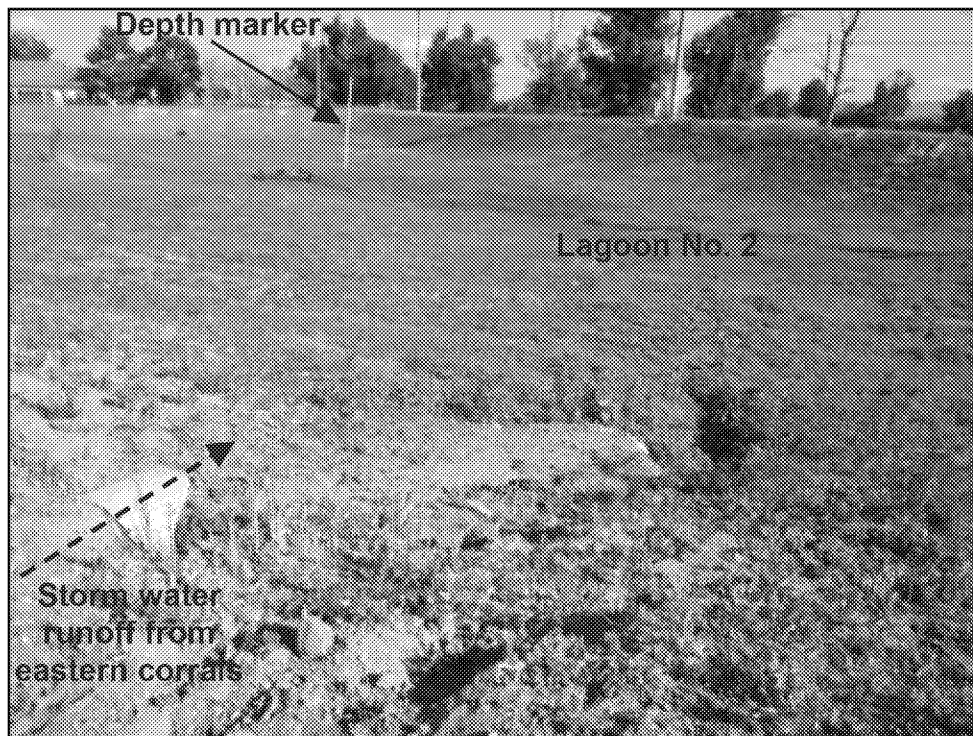
Photograph 8. View facing southeast of lagoon No. 2. Note storm water runoff from the eastern corrals enters lagoon No. 2 via a drain pipe from the 'Not Used' corral into the northwestern corner of lagoon No. 2.

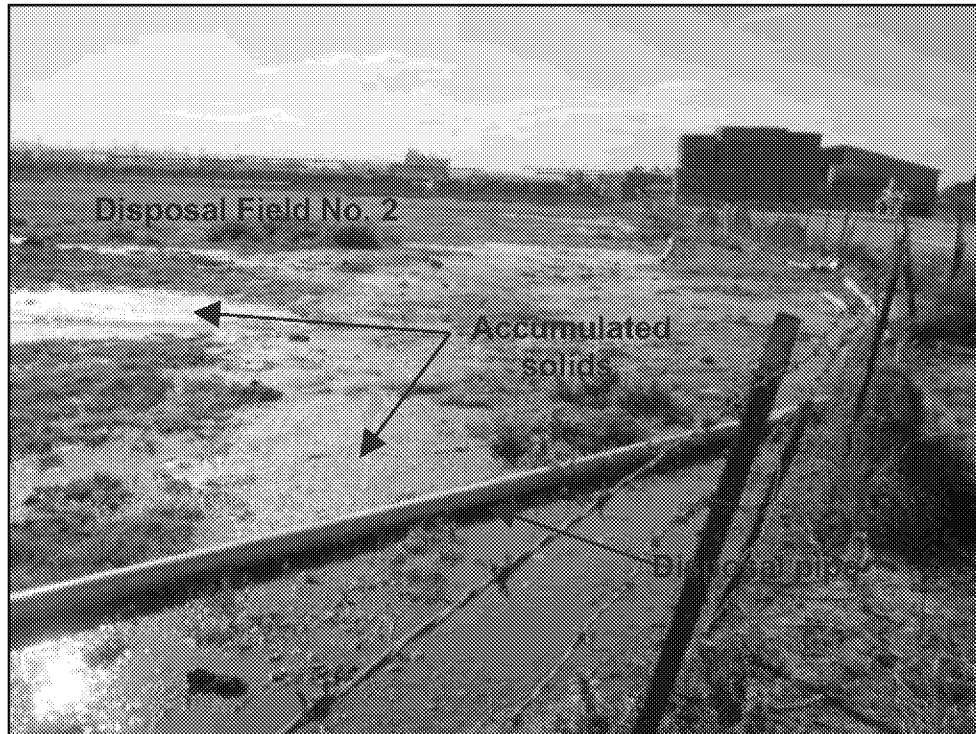
2. The inspectors observed, during the inspection, accumulated manure solids in field No. 2 in the central-east portion of the Facility (refer to Photos 10, 11, and 12). Mr. Jongsma stated that the disposal pipes in disposal field No. 2 are moved every couple of days and that the field is ripped as needed. Mr. Jongsma did not identify a field solids cleaning frequency timeframe; however, field Nos. 1 and 2 were last ripped in December 2012. Section V - 'Operation and Maintenance' of the EWMP identifies the 'removal and disposal of accumulated waste solids' as a routine maintenance item. The Discharger must design and maintain all containment structures per the EWMP as required by Provision VII.C.3.a.

Photograph 10. View facing southwest of disposal field No. 2. Note the ponding of process wastewater and accumulated solids were observed on the north side of field No. 2, adjacent to the disposal valves and pipes.

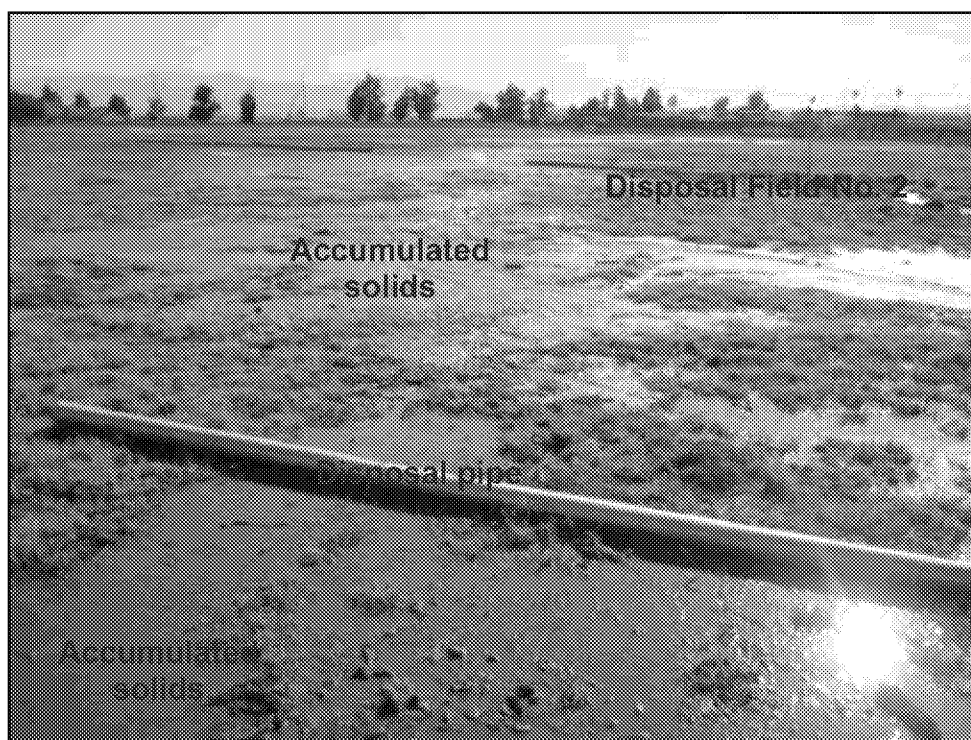
Photograph 11. Additional view facing south of disposal field No. 2, shown in Photograph 10.

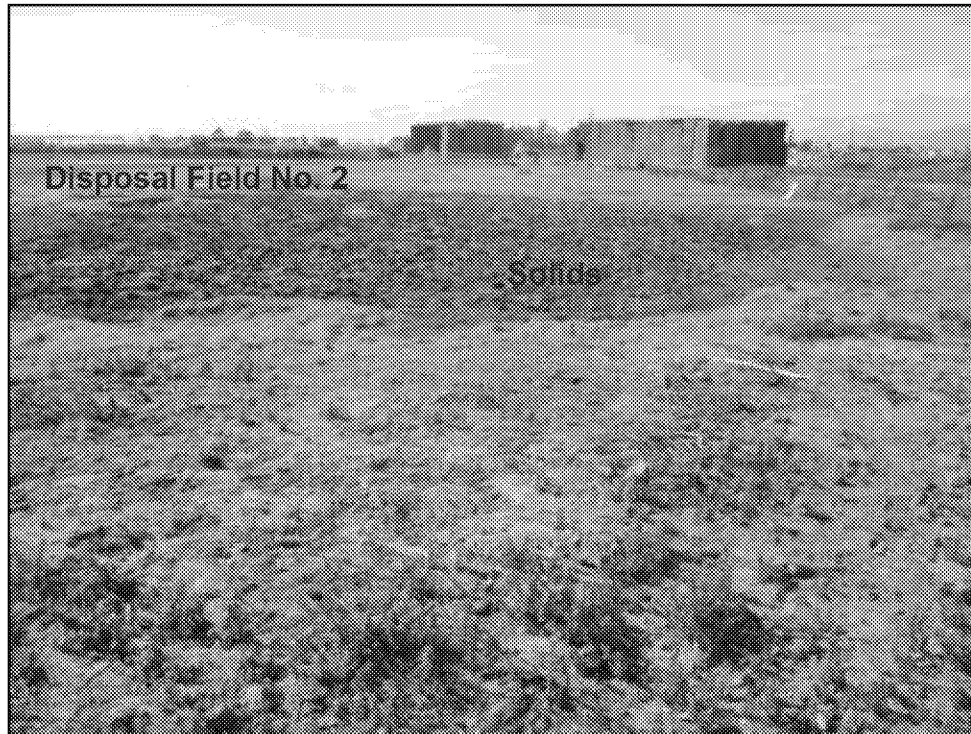
Photograph 12. View facing northwest of disposal field No. 2. Note the accumulated solids located in the northeast portion of the field.

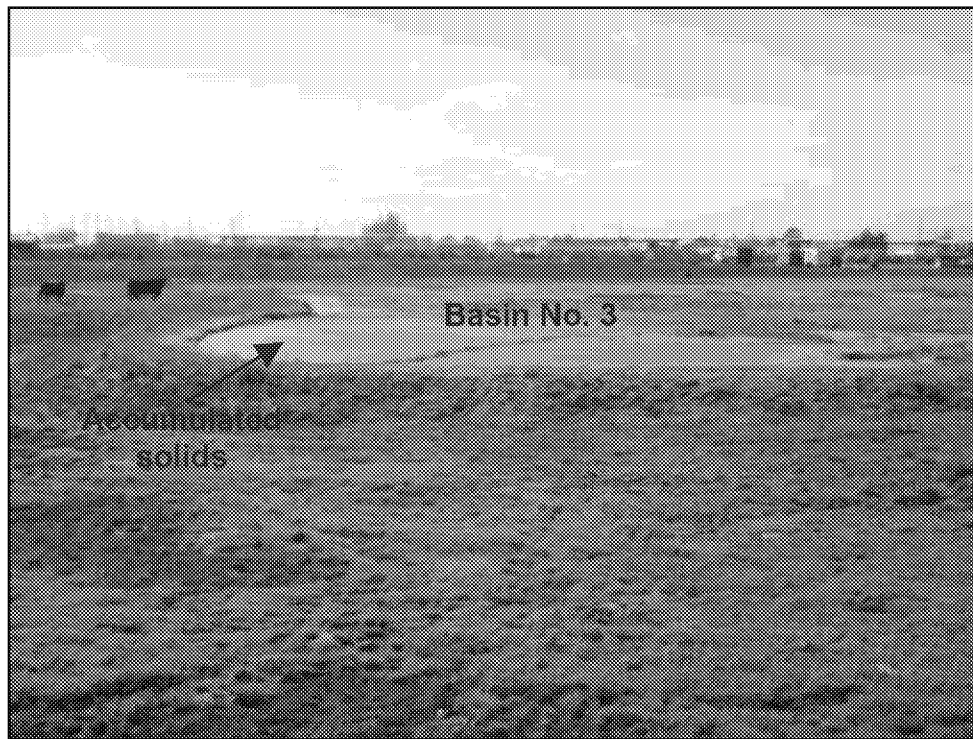
Photograph 13. View facing west of accumulated solids in basin No. 3, located on the south side of disposal field No. 2.

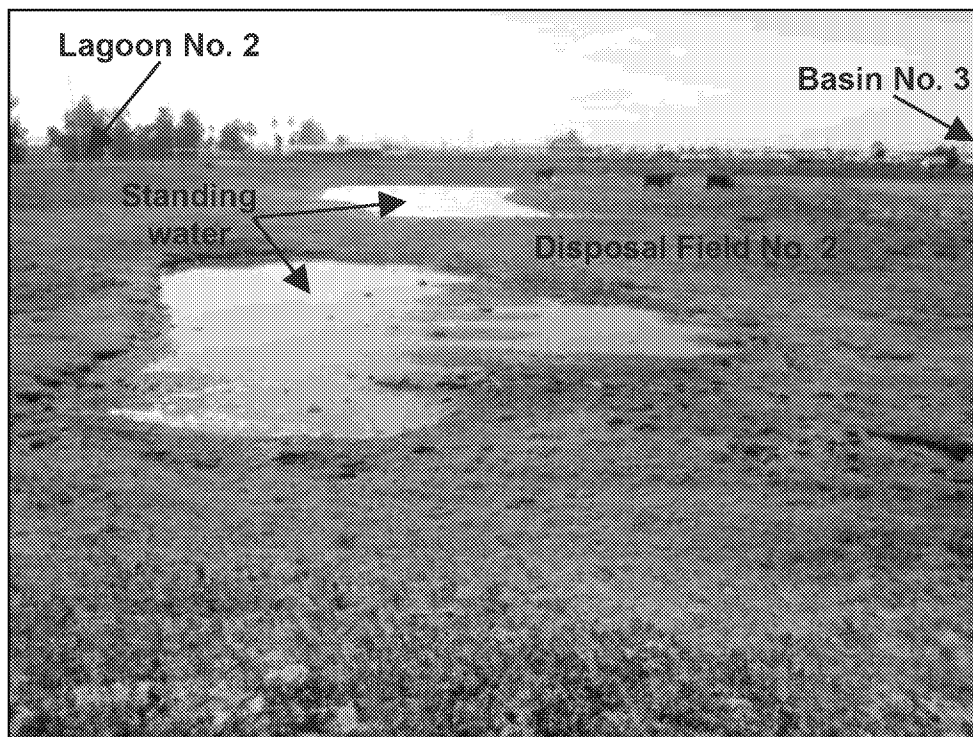
Photograph 14. View facing west of standing water on the south side of disposal field No. 2, between lagoon No. 2 and basin No. 3.

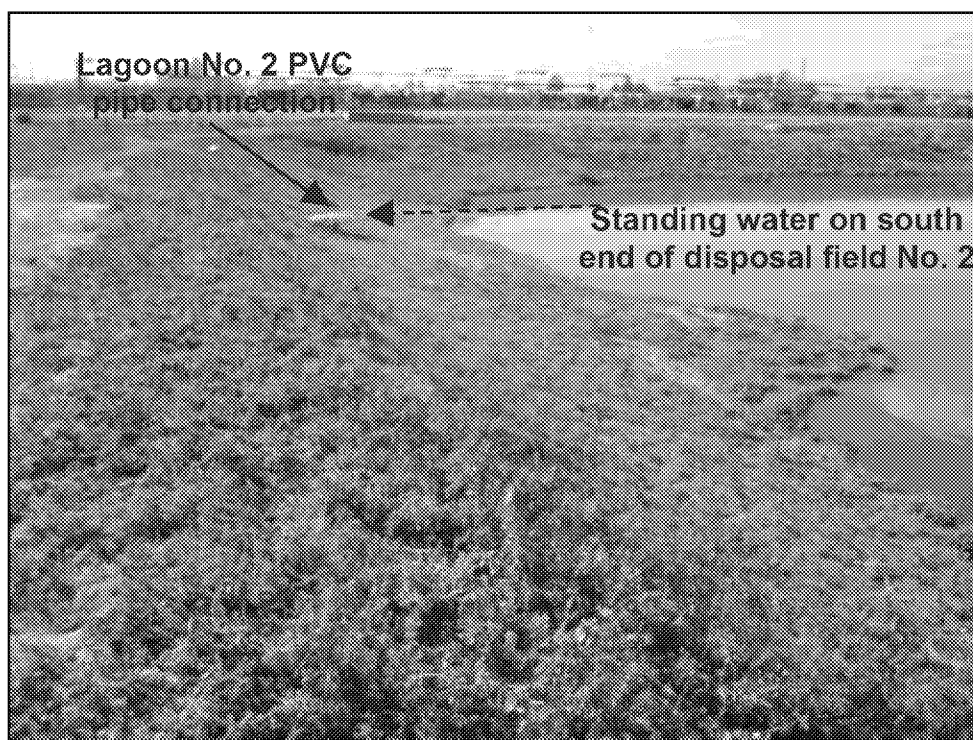
Photograph 15. View facing west of standing water on the south side of disposal field No. 2 and basin No. 3, upgradient of the PVC pipe connection which drains into lagoon No. 2.

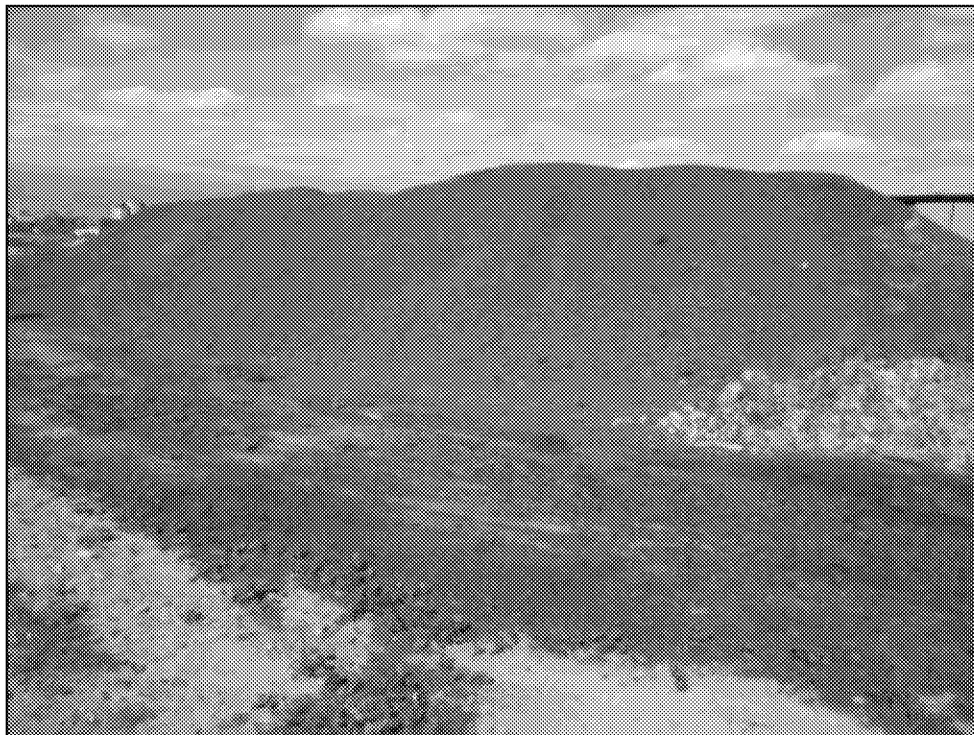
Mr. Jongsma stated that the corrals were last cleaned in December 2012. A manure stockpile from the most recent corral cleaning event was located in the central-west portion of the Facility, adjacent to disposal field No. 1 (refer to Photo 20). Manure is hauled offsite by multiple trucking companies. The exact disposal location was unknown by Mr. Jongsma at the time of the inspection. Manure tracking manifests are maintained of all haul events at the central Jongsma Dairy office in the California Central Valley. Mr. Jongsma stated that all mortalities are removed from the Facility immediately by Stiles Animal Removal, Inc.

Photograph 20. View facing northeast of a manure stockpile located on the central-west portion of the Facility, adjacent to disposal field No. 1.
